Manhole Inspection Summary

Manhole # S31WW1016MH

Insp Date: **1/16/07 3:08 PM**

Location Address: **117 TUNBRIDGE RD**

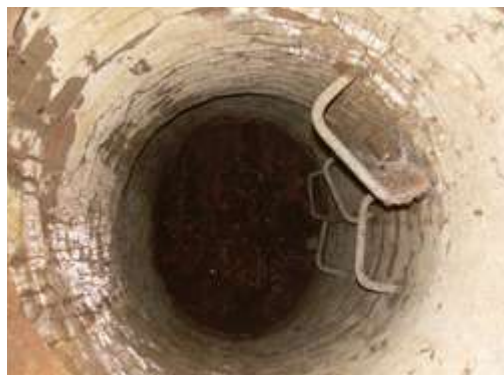
Top View

Channel debris.

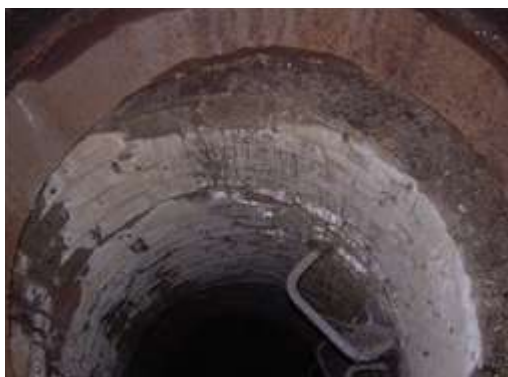
Defect

Frame offset. Adjustment and Corbel infiltration

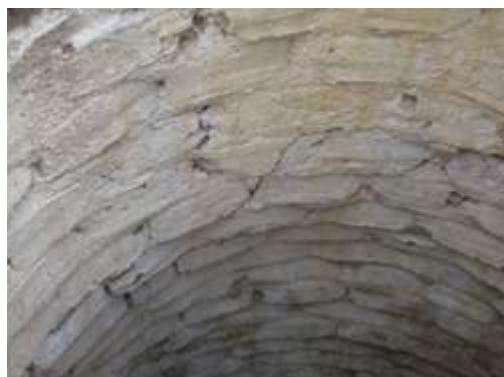
Defect

Adjustment deterioration, cracks and infiltration.

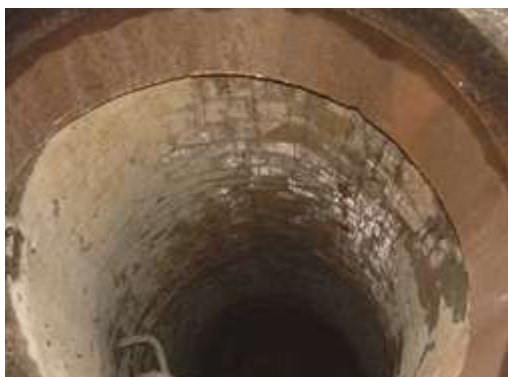
Defect

Adjustment and Corbel infiltration - other side.

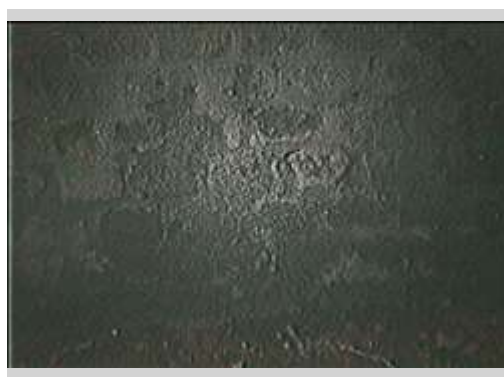
Defect

Barrel infiltration.

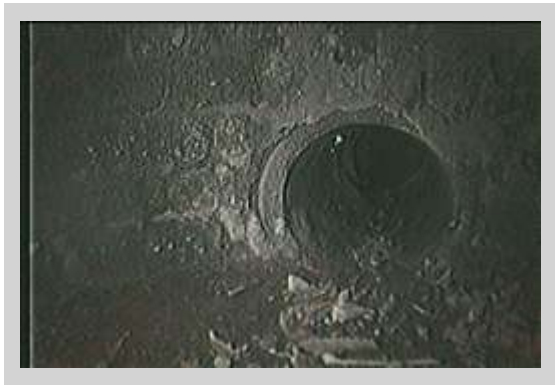
8 in. Circular Gravity Sewer
Pipe Out @ 12 O'Clock

Deposits: ☐ None ☒ **Mud** ☐ Sludge ☒ **Debris** ☐ Grease

Infiltration: **Evidence** Pipe Seal Cond: **Unknown**
